Data Create	2015/03/23	Release Note	<input type="checkbox"/> Internal <input checked="" type="checkbox"/> External
Category	FAQ	Product Group	IAG
Function	Notification	Related OS	Win XPE & WinCE
Related Product	ADAM-5053S & ADAM-5560

Older ADAM-5053S can't be inserted in the slot 0 of ADAM-5560 because of the components interference problem of ADAM-5053S and ADAM-5560.

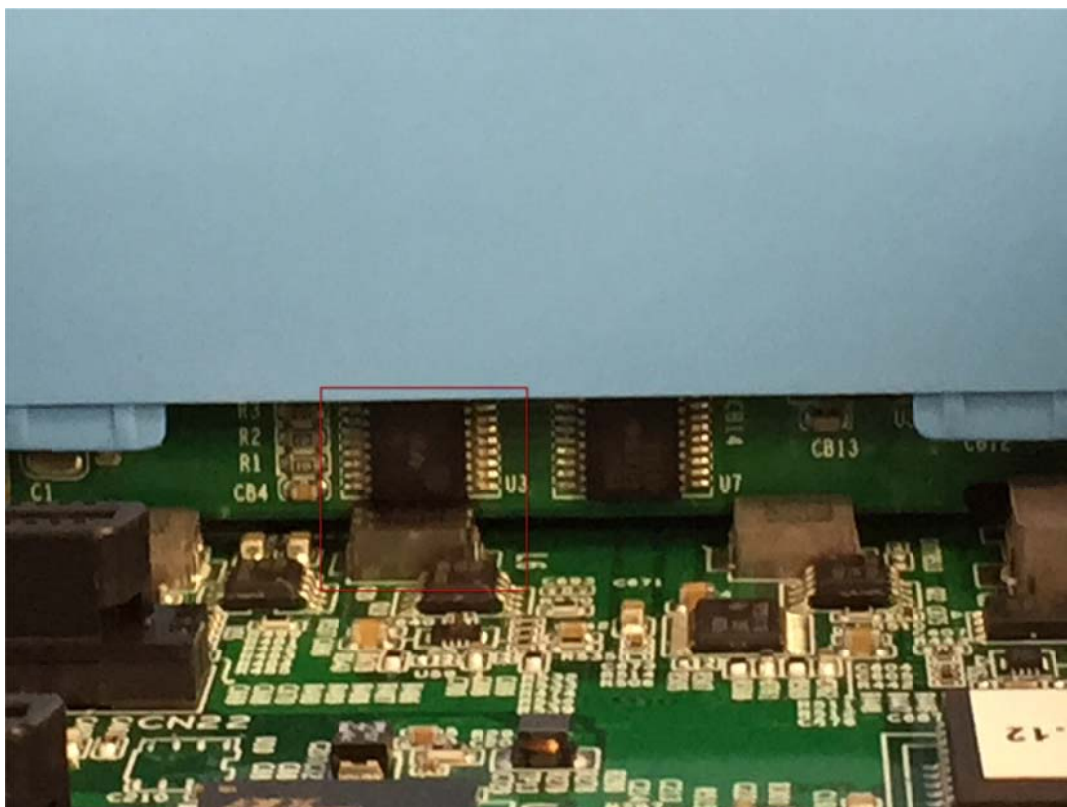
1. If you plug the older ADAM-5053S on the slot 0 position of ADAM-5560, the component "U3" on the older ADAM-5053S will be broken by the component "L6" on ADMA-5560 backplane.

1. Don't plug the older ADAM-5053S on the slot0 of ADAM-5560.
2. The ECOM-106401 of ADAM-5053S that modifies the U3/U4 location will be imported.
