Advantech AE Technical Share Document

Date	2019 / 08 / 23	Release Note	<input type="checkbox"/> Internal <input checked="" type="checkbox"/> External
Category	<input checked="" type="checkbox"/> FAQ <input type="checkbox"/> SOP	Related OS	Embedded Windows 10
Abstract	FAQ_How to solve the problem of BitLocker initialization failure on embedded Windows 10?		
Keyword	Embedded Windows 10 / BitLocker		
Related Product	All ASG products which support Embedded Windows 10

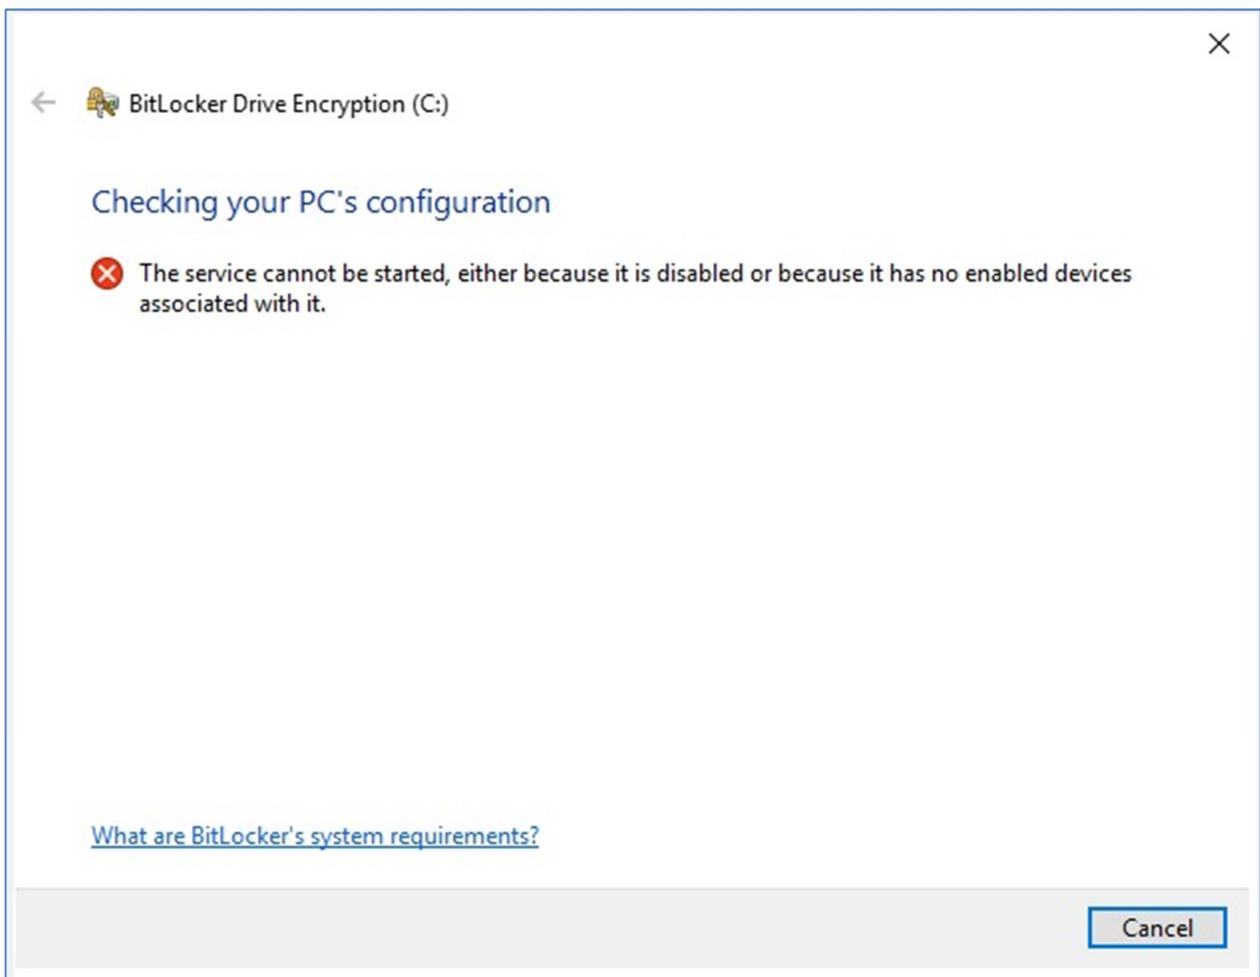
On Advantech Embedded Windows 10, user may encounter the problem of BitLocker initialization failure, as shown below

Because the service of Optimize drives is disabled by default, user is not able to initialize BitLocker. We will provide a new Windows 10 image for each product, which the Optimize drives service will be enabled by default. Before that, you may manually enable it.
